# **Waste Minimisation at a Manufacturing Company (MF5)**

## **Case Study 2**

### **Metal Finishing Waste Minimisation Club**

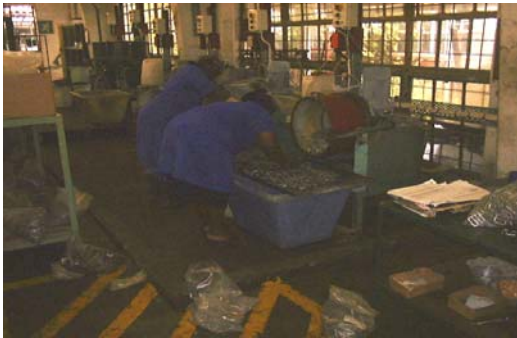
Raw material is brought in as metal ingots and undergoes a number of processes such as zinc casting (both spin and pressure die-casting); metal processing; tumbling and electroplating. Copper Brass, Zinc, Nickel, Silver or Gold plating may be carried out on the trims. Those areas that were identified as the main sources of waste were the tumbling (see diagram on left) and plating departments.

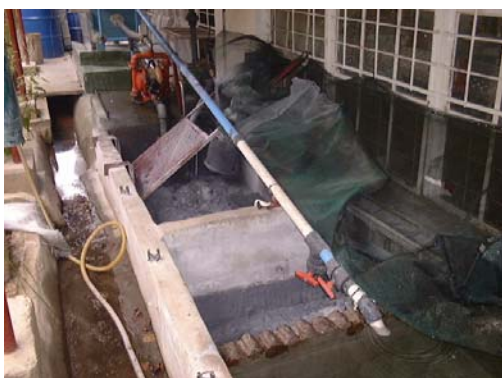
In an effort to reduce both the water use and the mass of sludge produced, methods of recycling this water were investigated. The solution was to install a filter press to remove the fine metal particles and recycle the water back into the process (see diagram on left). The sludge that is produced is more compact and dryer, resulting in less volume requiring disposal. Chemical costs are also reduced as less chemicals are required for effluent treatment.

Tumbling is a process where deburring, polishing and paint removal of the trims occurs. The trims are placed in mini-grinders with a grinding media and tumbled for between 1 and 2 hours depending on the finish required. Water is used throughout the grinding process to continuously remove the fine metal particles that are created during the deburring process. As a result, large volumes of water were consumed and a large quantity of sludge produced.
